**DEBRIS CONTROL AT HYDRAULIC
STRUCTURES IN SELECTED AREAS
OF THE USA**

January 1996

Second Interim Report

US ARMY RESEARCH DEVELOPMENT &
STANDARDIZATION GROUP-UK
LONDON

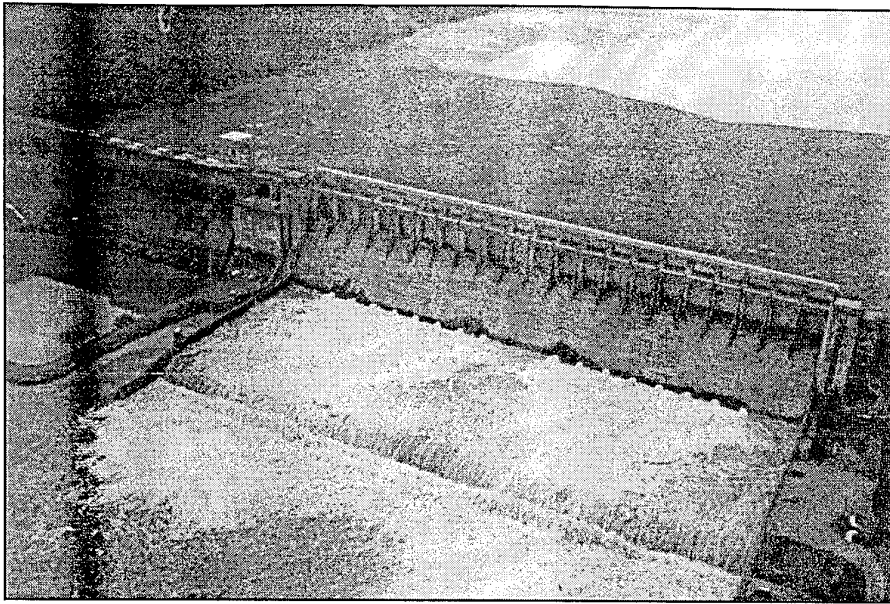
The larger debris accumulations span the width of the river valley and wedge against the dam face. A photograph of the March 1993 flood event is presented in Enclosure 3. Approximately 40 acres of drift and debris are observed prior to passage. In addition, a photograph illustrating the January 1995 event demonstrates how the debris compacts against the dam face. Approximately 35 acres of debris accumulated during the January flood.

Bluestone Dam, March 1993, Flood Event

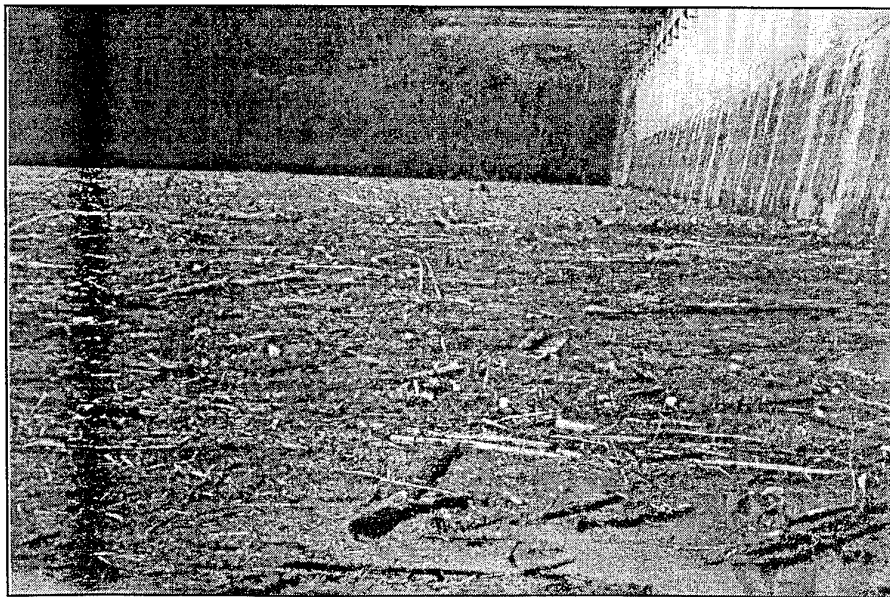
Bluestone Dam, January 1995, Flood Event

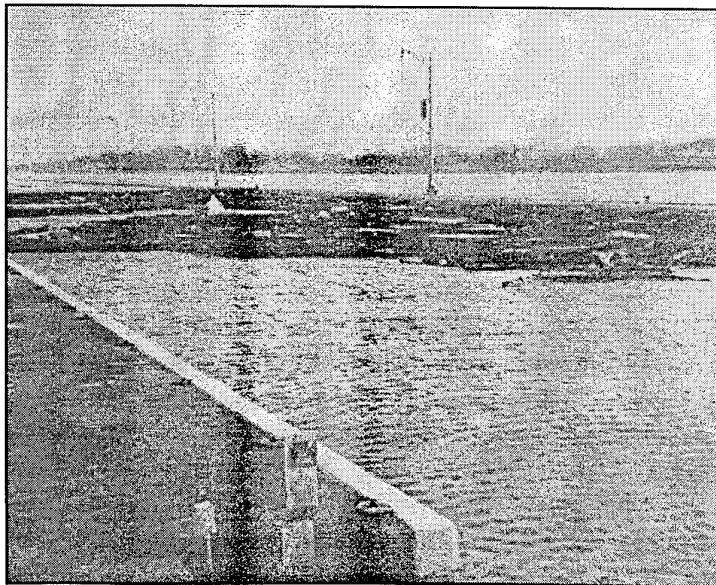
Enclosure 4 illustrates a typical debris jam in the Jonesville Lock (March 21, 1995). Drift has been observed to nearly fill the 600-foot lock.

Black River, March 1995

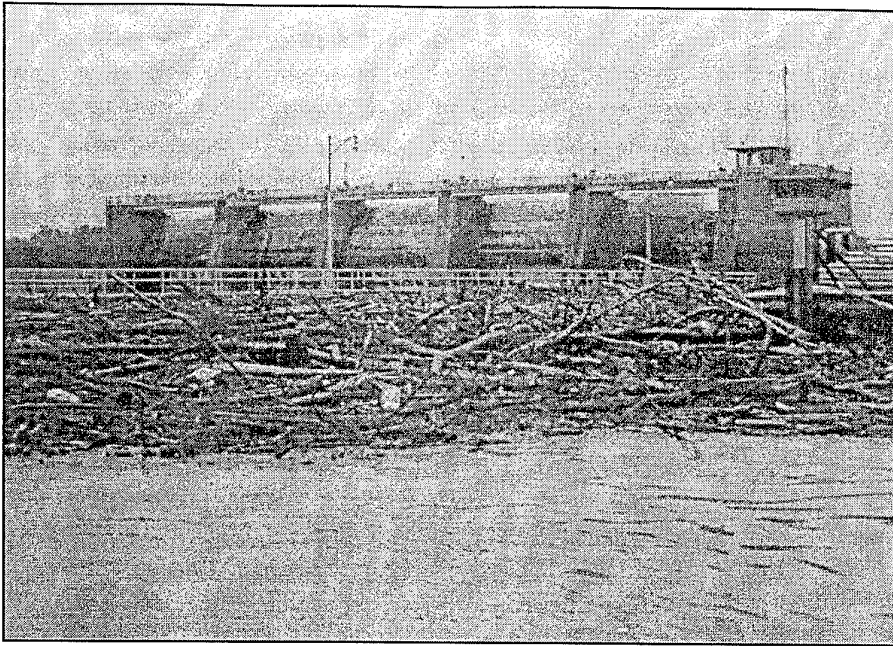
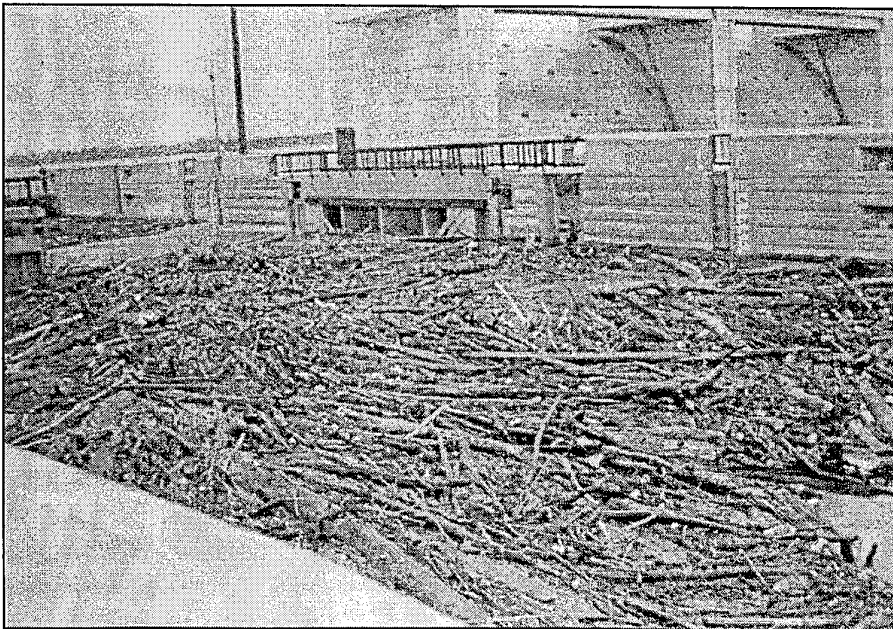
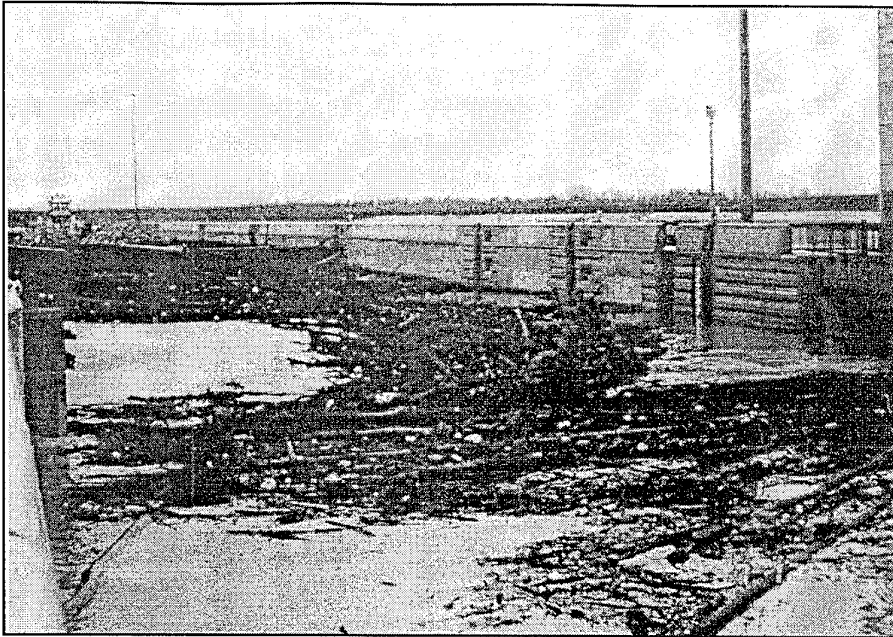
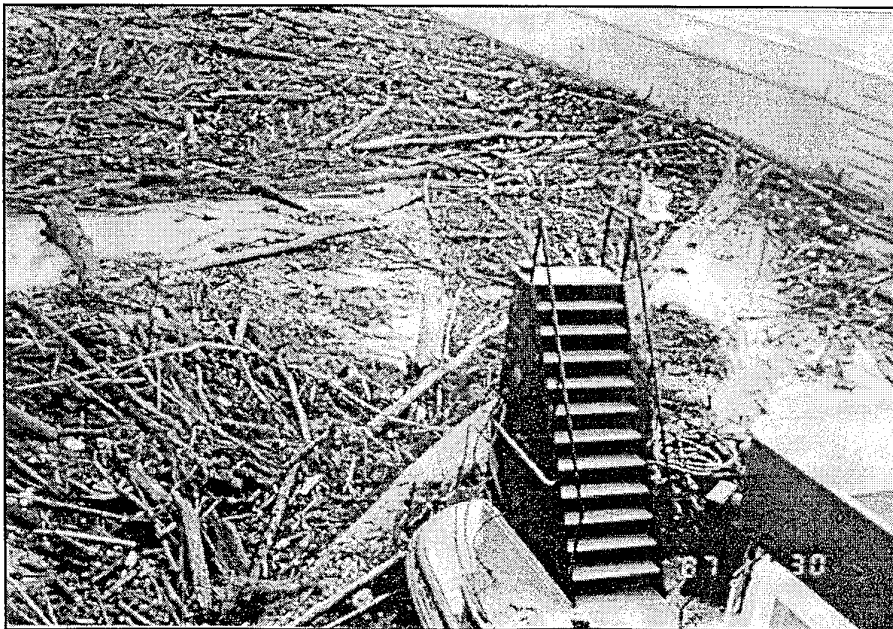
Typical log jam, Lock and Dam Operation

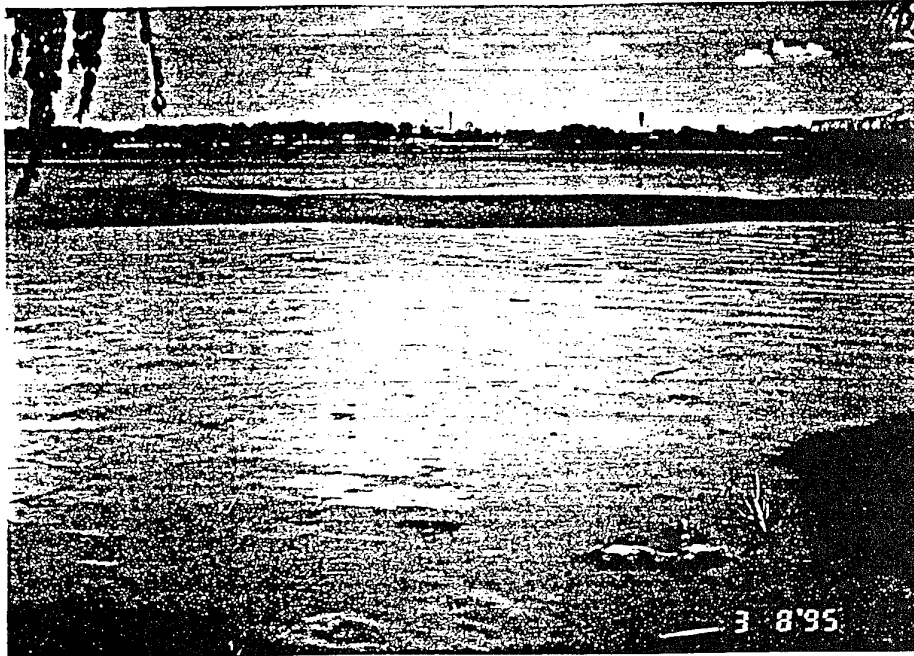
FIGURE A - MUD FLATS UPSTREAM OF MCALPINE L&D
(looking toward Indiana shore)

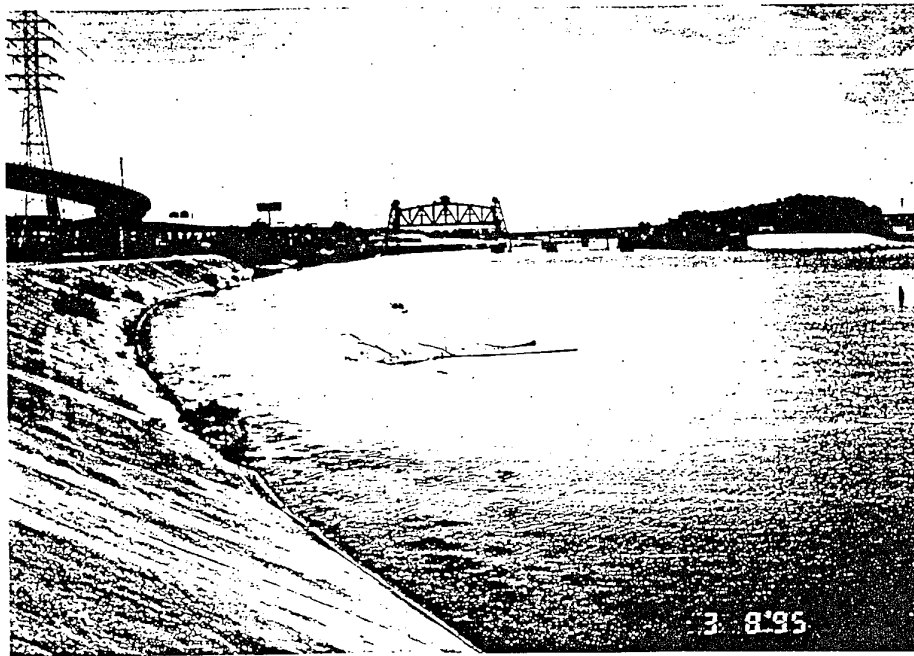
FIGURE B - MUD FLAT UPSTREAM OF MCALPINE WITH DEBRIS ACCUMULATION
(looking downstream toward canal)
